**Flood Control Project Maintenance  
Levee Inspections**  
**LMA District Cover Sheet**  
**Spring 2018 Levee Inspection Results**

**Reclamation District No. 1001 Nicolaus**

**Spring 2018 Levee Inspection Results**

| Waterway | | | Bank | Unit Miles |
|--|---|---|---|---|
| Unit No. 01 Yankee Slough | | | Right | 4.12 |

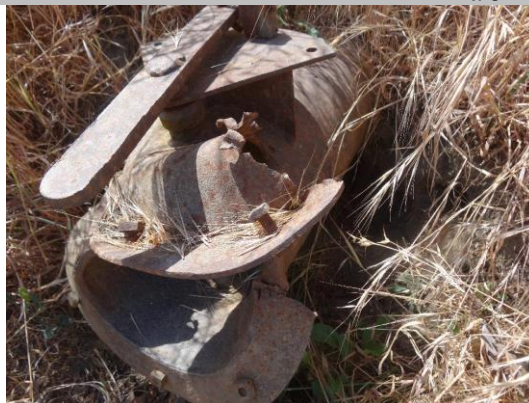
Photo 3 of 3 : UCIP\_SP\_2018\_50740\_22751.jpg

| FS_ID:50740<br>DS_ID:22529<br>EP_NO: 2281<br>Repair Type: Non-Urgent<br>Crossing Status: Not Found<br>UCIP Comments: 07/13/2016 According to district president Joe Henderson, pipe was removed 2-3 years ago. No permit for removal found or evidence of pipe or its removal found. (K. Fazel - UCIP)05/23/2013:- leaky pipe end and erosion on WS.- cracked dirt mound on LS - seems not been used for some time. (P. Amatya - DWR)<br>FIELD_STRUCT_DESC: *REMOVED* 7-inch steel irrigation pipe through the levee, 1.9 feet below the crown. Portable pump mounted on the bank during the summer months. Control valve on the waterside (WS). Steel plate bolted on the WS end during the winter months. Pipe discharges into a 30-inch concrete standpipe at the landside (LS) toe. (Pump and irrigation pipe authorized under Permit No. 2281, 1956 - Willard R. Brown). [Additional Reference(s): DWR Levee Log, 1993].<br>FS Date: 7/13/2016 | | | | | | |

WS- due to water leak, soil around pipe eroded.

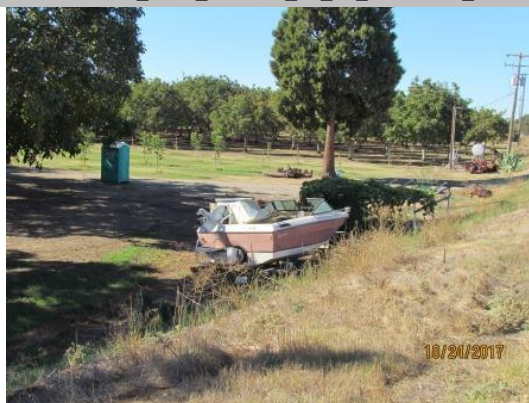
Photo 1 of 1 : SP\_2018\_RD1001\_35\_19\_20180302\_00012.jpg

View of a boat at the landside levee toe, Fall 2017.

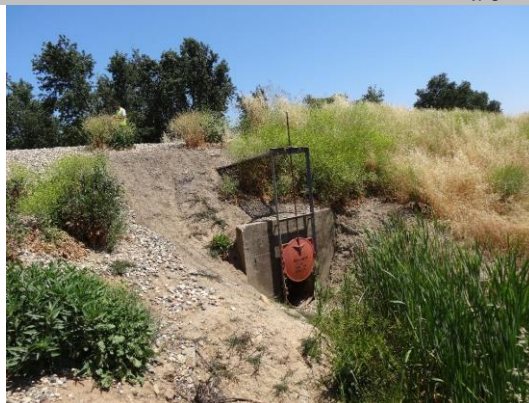
Photo 3 of 3 : UCIP\_SP\_2018\_14008\_23106.jpg

| FS_ID:14008<br>DS_ID:22543<br>EP_NO: N/A<br>Repair Type: Non-Urgent<br>Crossing Status: Found<br>UCIP Comments: - slide gate in inlet pipe on landside - pits on pipe due to corrosion<br>FIELD_STRUCT_DESC: 36-inch corrugated metal gravity drainage pipe through the levee, 15 feet below the crown. Flap gate and concrete U-shaped headwall at outfall on the waterside (WS) end. Slide gate at inlet on the landside (LS) end. (Reclamation District No. 1001).<br>[Additional Reference(s): DWR Levee Log, 1993. USACE Sacramento O&M Manual 141.1, August 1955, (Station 67+75)].<br>FS Date: 5/23/2013 | | | | | | |

LS- slide gate in inlet pipe structure

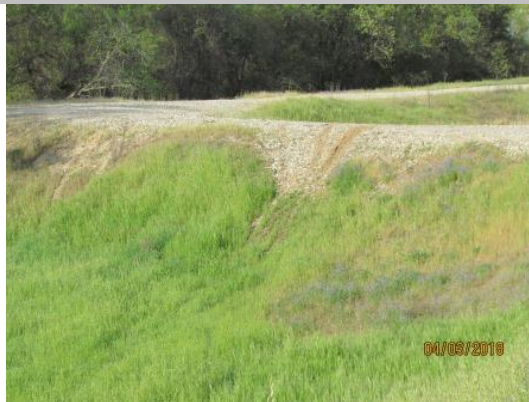
Photo 1 of 1 : SP\_2018\_RD1001\_37\_2\_20180409\_00055.jpg

| Rutting caused by vehicles driving up the landward levee slope, Spring 2018. | | | | | |

View of rutting on the landside levee facing downstream. Spring 2018.

| S3 : Repair the levee slope damaged by vehicle traffic and prevent access where possible. | | | | | |

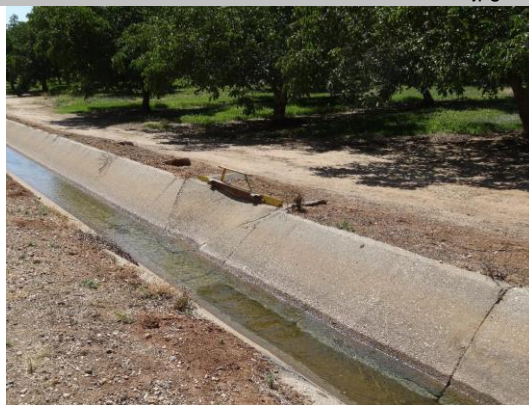
Photo 3 of 3 : UCIP\_SP\_2018\_14128\_23309.jpg

| UCIP Comments: - slide gate on WS not found- needs abandoned properly. | | | | | | |

LS- no pipe or structure found on landside.

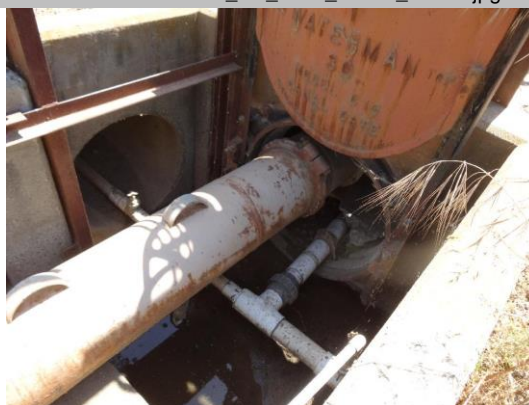
Photo 3 of 3 : UCIP\_SP\_2018\_41727\_23323.jpg

| FS_ID:41727<br>DS_ID:22561<br>EP_NO: 4505<br>Repair Type: Non-Urgent<br>Crossing Status: Found<br>UCIP Comments: Two small steel pipes sleeved through 30-inch CMP may be a compliance issue as slidegate cannot close.- this may have been converted into drainage pipe (?) - big CMP standpipe on WS.<br>FIELD_STRUCT_DESC: 30-inch concrete encased corrugated metal irrigation pipe through the levee, 11 feet below the crown. Concrete headwall and slide gate at the waterside (WS) toe, removed. Metal walkway on the WS to the slide gate. Pipe discharges into a 48-inch concrete standpipe at the landside (LS) toe. Two vertical pumps. (30-inch concrete encased corrugated metal irrigation pipe authorized under Permit No. 4505, 1964 - State of California, Department of Public Works, Division of Highways). [Additional Reference(s): DWR Levee Log, 1993. USACE Sacramento O&M Manual 141.1, August 1955, (Station 949+00), 30-inch steel pipe referenced].<br>FS Date: 5/21/2013 | | | | | | |

WS- two steel pipes are sleeved through 30-inch CMP.

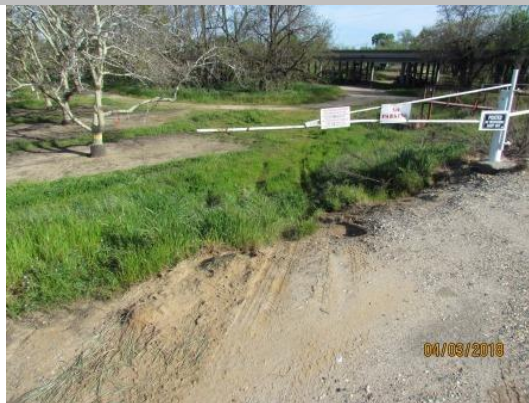
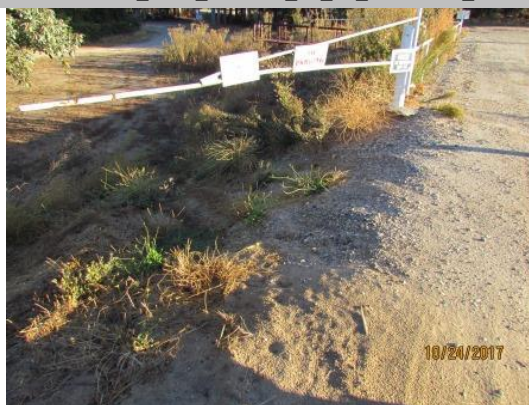
| Continual damage to waterside slope caused by vehicles, suggest blocking access. | | | | | |

Continual damage to waterside slope caused by vehicles. Spring 2018.

Continual damage to waterside slope caused by vehicles. Fall 2017.

| S3 : Repair the levee slope damaged by vehicle traffic and prevent access where possible. | | | | | |

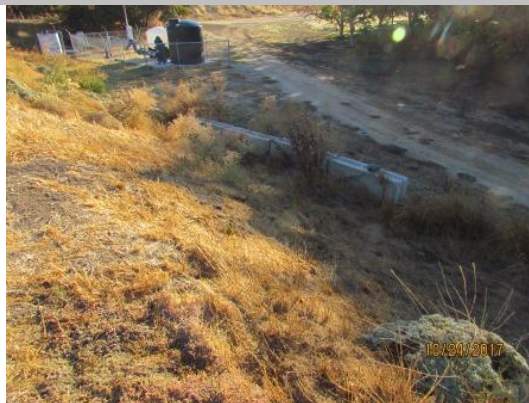
Photo 1 of 1 : SP\_2018\_RD1001\_37\_29\_20180302\_00023.jpg

| Continual damage caused by vehicles going around the gate, has been fixed and blocks added. | | | | | |

Continual damage caused by vehicles going around the gate. Fall 2017.

| S3 : Repair the levee slope damaged by vehicle traffic and prevent access where possible. | | | | | |

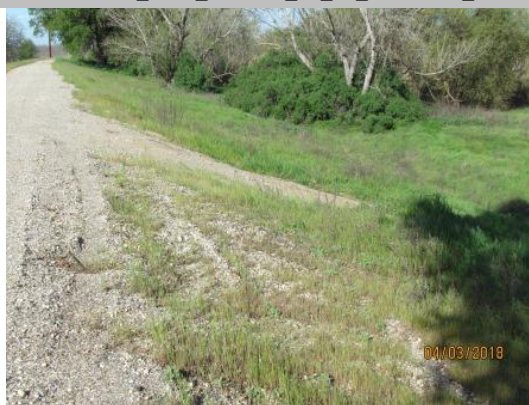
Photo 1 of 2 : SP\_2018\_RD1001\_37\_30\_20180409\_00059.jpg

| Damage to landside slope by vehicles needs to be repaired, Spring 2018. | | | | | |

View looking downstream waterside where slope has been disturbed by vehicle traffic, Spring 2018.

| S3 : Repair the levee slope damaged by vehicle traffic and prevent access where possible. | | | | | |

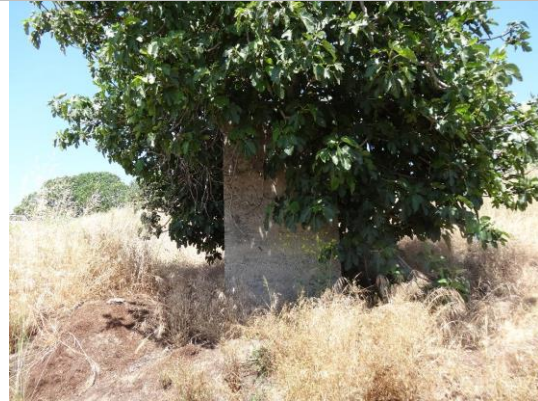
Photo 2 of 2 : UCIP\_SP\_2018\_41722\_23337.jpg

LS- a big tree inside concrete standpipe.

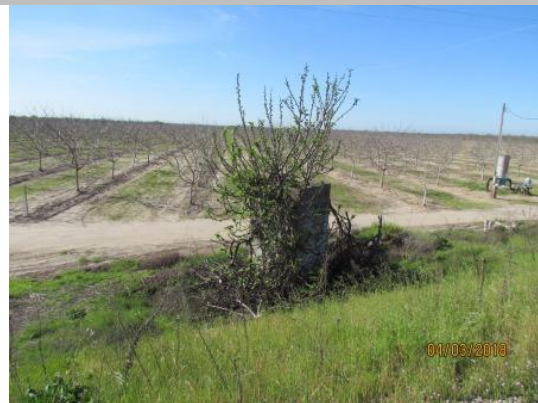
Photo 1 of 1 : SP\_2018\_RD1001\_37\_36\_20180409\_00061.jpg

View of a small starter tree on landside slope looking downstream that is less than 4" in diameter, Spring 2018.

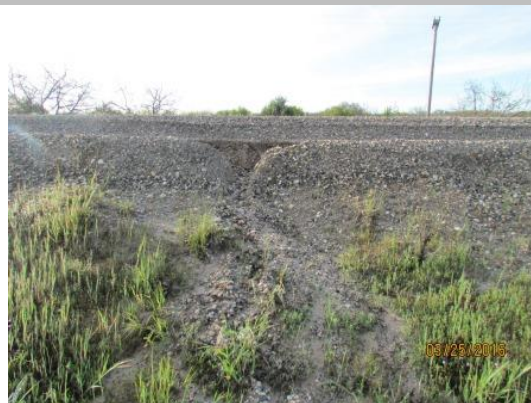
Photo 2 of 2 : SP\_2018\_RD1001\_37\_21\_20180302\_00019.jpg

Erosion on waterside slope. Remains as of Fall 2016.

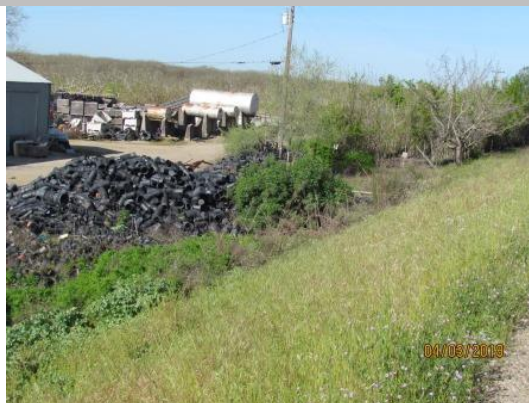
Photo 2 of 2 : SP\_2018\_RD1001\_37\_7\_20180409\_00065.jpg

Irrigation pipe equipment and plastic cans within the easement of the levee. Spring 2018.

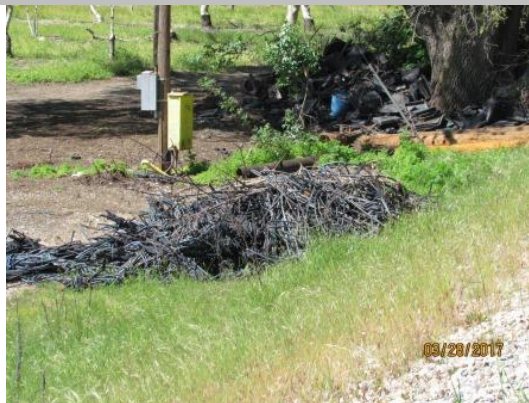
Photo 2 of 2 : SP\_2018\_RD1001\_37\_26\_20180302\_00021.jpg

View of drip irrigation and trash on levee slope. Spring 2017.

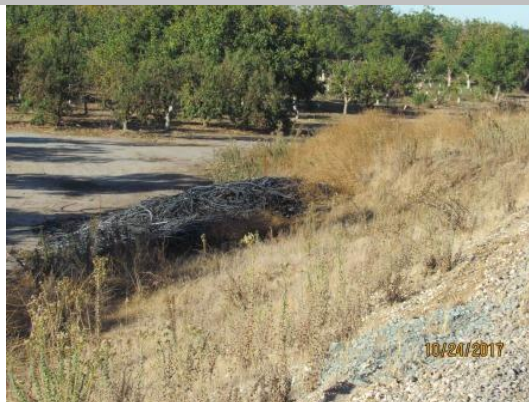
Photo 2 of 2 : SP\_2018\_RD1001\_37\_35\_20180302\_00028.jpg

View looking downstream landside of drip irrigation and trash on levee slope. Fall 2017.

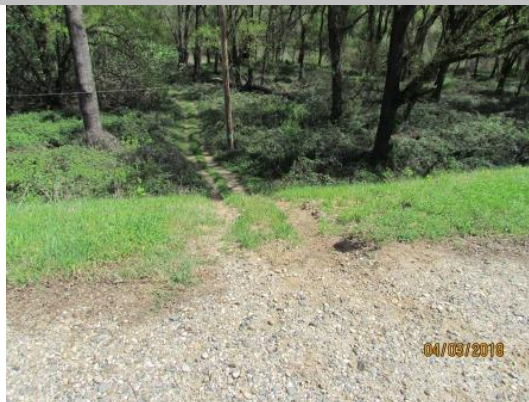
Photo 1 of 1 : SP\_2018\_RD1001\_38\_63\_20180411\_00088.jpg

View of landside slope erosion caused by vehicles, Spring 2018.

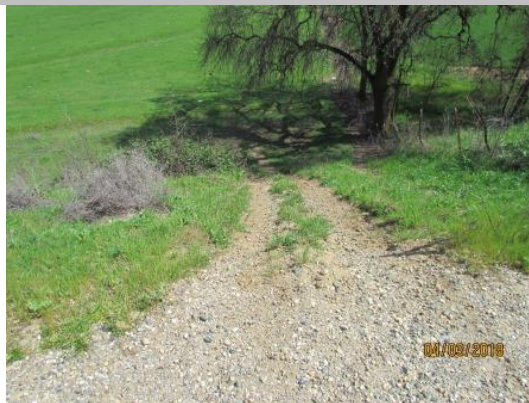
Photo 1 of 1 : SP\_2018\_RD1001\_38\_68\_20180411\_00090.jpg

View of ruts caused by vehicle on the landside levee slope. Spring 2018.

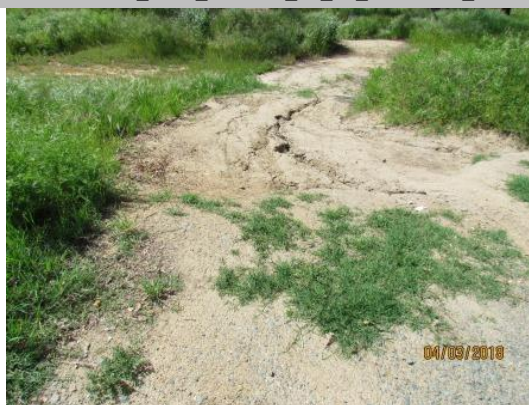
Photo 1 of 1 : SP\_2018\_RD1001\_38\_70\_20180411\_00096.jpg

View looking downstream waterside of the slope that is damage by vehicle traffic, Spring 2018.

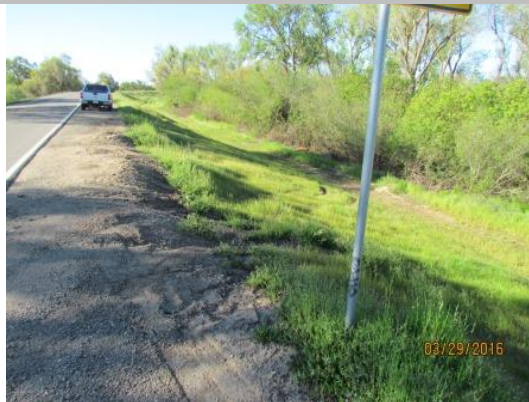
Photo 1 of 2 : SP\_2018\_RD1001\_38\_78\_20180302\_00059.jpg

Ruts on waterside slope due to vehicles. Spring 2016.

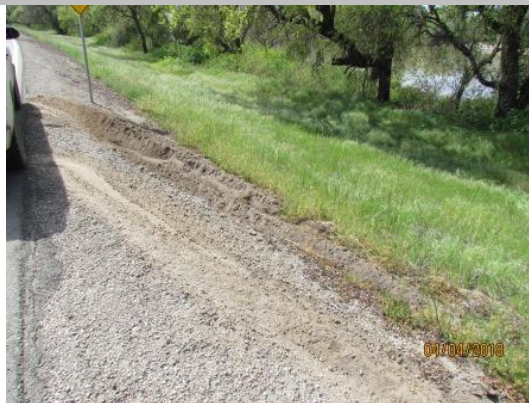
Photo 1 of 1 : SP\_2018\_RD1001\_38\_40\_20180411\_00097.jpg

View looking downstream waterside at deep tire ruts in levee slope, Spring 2018.

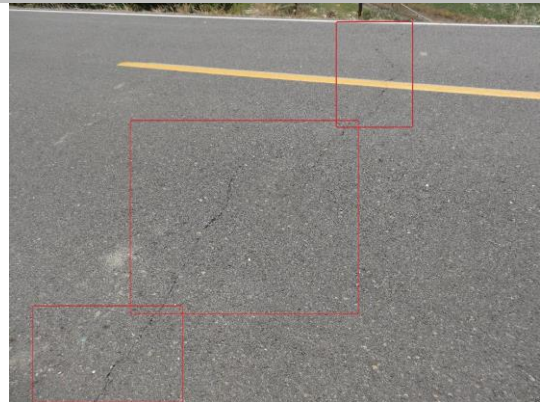
Levee Crown- road surface cracks along the pipe. Needs more investigation.

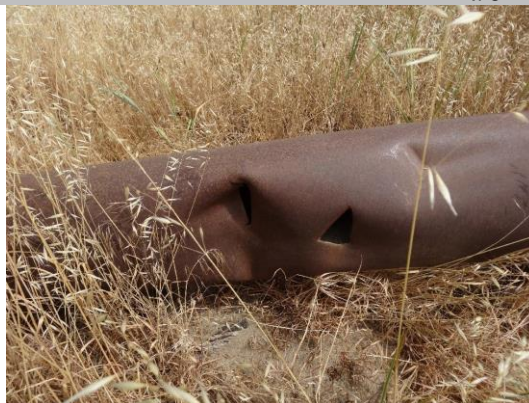
Photo 2 of 3 : UCIP\_SP\_2018\_14544\_23965.jpg

WS- abandoned damaged pipe with holes, cracks on levee slope.

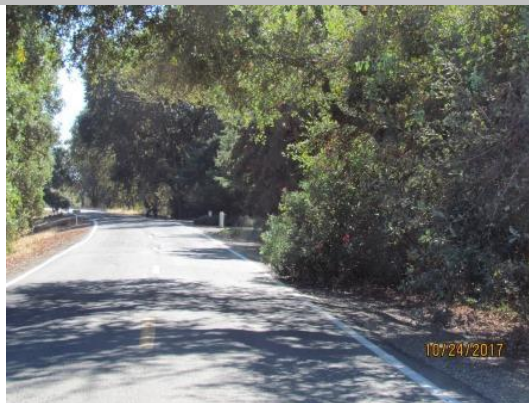
Photo 1 of 1 : SP\_2018\_RD1001\_38\_37\_20180302\_00027.jpg

View looking downstream waterside of landscaping vegetation encroaching onto the levee crown, Fall 2017.

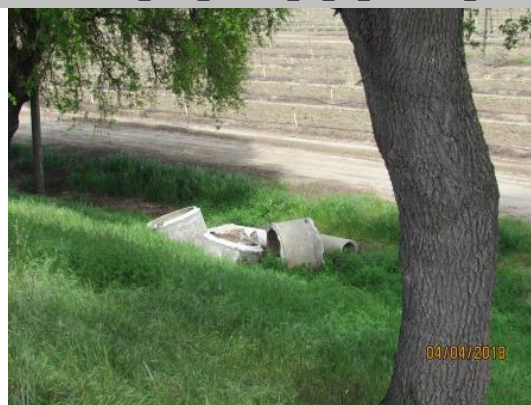
Photo 1 of 1 : SP\_2018\_RD1001\_38\_41\_20180411\_00099.jpg

View of the material at the landside levee toe, Spring 2018.

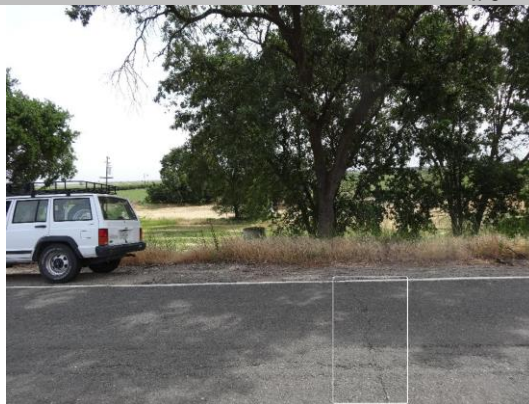
Photo 2 of 3 : UCIP\_SP\_2018\_14548\_23969.jpg

Levee Crown- surface crack along pipe crossing. Needs more investigation.

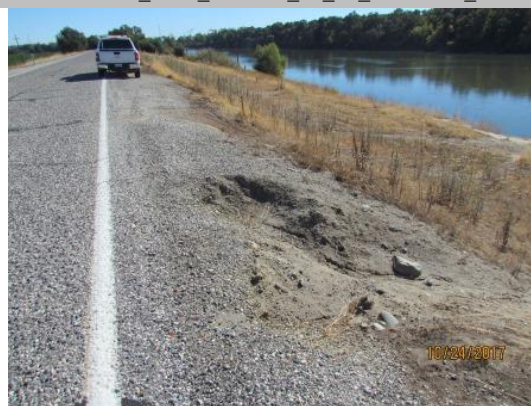
Photo 1 of 1 : SP\_2018\_RD1001\_38\_50\_20180302\_00038.jpg

View looking downstream waterside of damages cause by vehicles driving on the levee slope, Fall 2017.

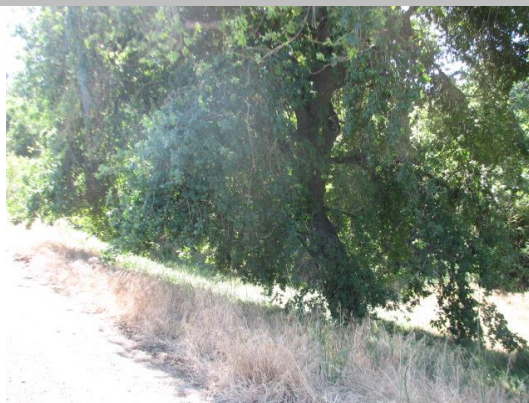
Photo 1 of 1 : SP\_2018\_RD1001\_38\_151\_20180302\_00063.jpg

Trees need to be trimmed up at least 5 feet. Spring 2013

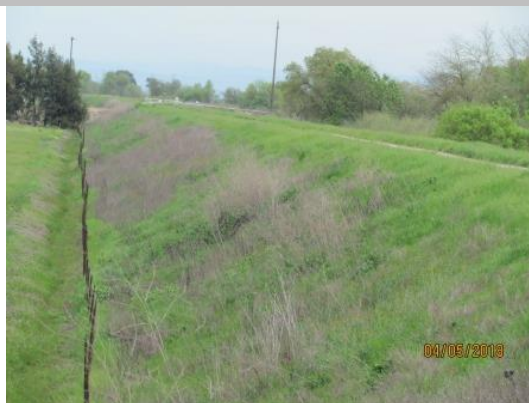
Photo 1 of 1 : SP\_2018\_RD1001\_40\_1\_20180411\_00041.jpg

View looking upstream landside of the annual vegetation that has gotten too tall and needs to be maintained for better visual inspection, Spring 2018.

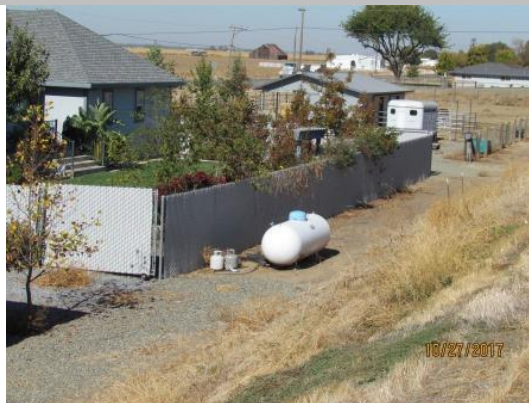
Photo 1 of 1 : SP\_2018\_RD1001\_40\_46\_20180302\_00014.jpg

View of a propane tank that is within the landside easement of the levee. Fall 2017.

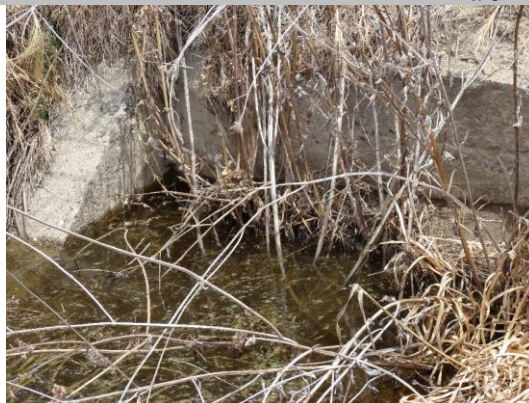
Photo 3 of 3 : UCIP\_SP\_2018\_14223\_23443.jpg

LS- pipe submerged/buried in concrete wing wall on levee toe

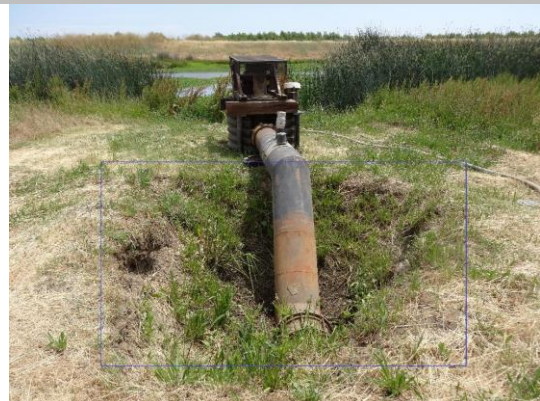
Photo 2 of 3 : UCIP\_SP\_2018\_50692\_23429.jpg

WS- large depression on levee berm

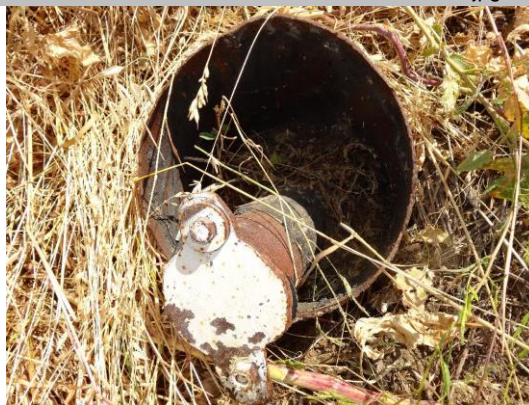
Photo 2 of 2 : UCIP\_SP\_2018\_13523\_22120.jpg

WS- gap between two pipes needs to be filled.

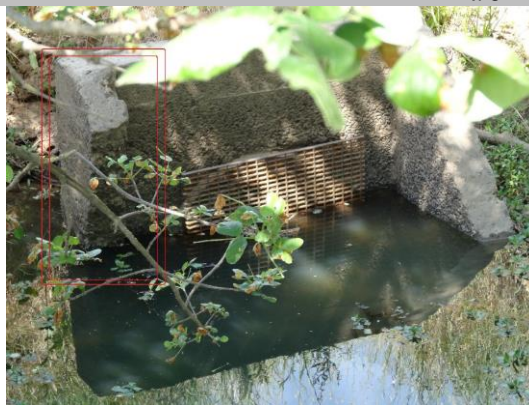
Photo 3 of 3 : UCIP\_SP\_2018\_41724\_22032.jpg

WS- inlet pipe with trashrack in a damaged wing wall

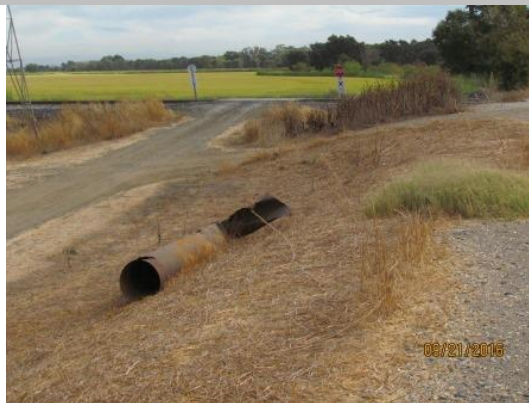
Photo 2 of 2 : SP\_2018\_RD1001\_40\_24\_20180302\_00013.jpg

View of an old piece of pipe lying on landside levee slope looking upstream. Fall 2016.
